PROPERTY INSPECTION REPORT

311 Robinson

Report Identification: 3111 ROBINSON 091812

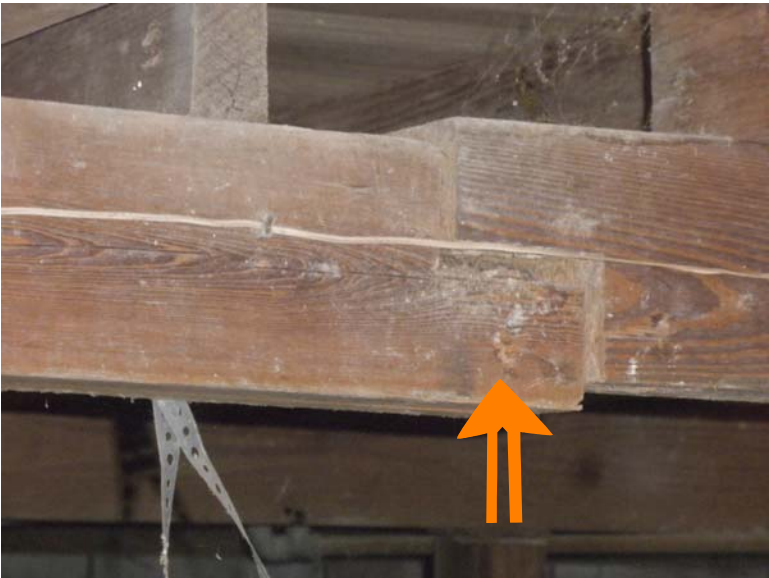
needs repair and leveling. Some piers have fallen over, beam splice unsupported (under DR), some beams not touching the piers under them, some wood to earth contact (attracts termites). Some amateur piers (stacked bricks and block)

1 need pier under beam splice under DR

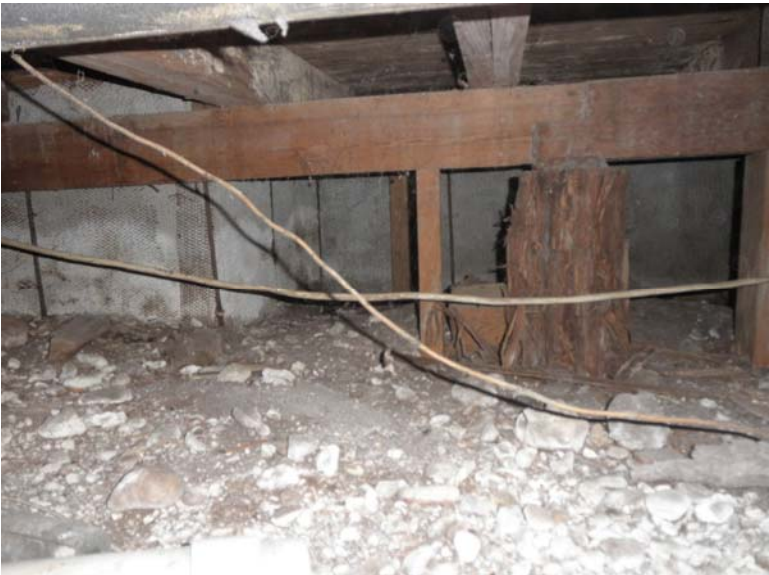
2 earth to wood contact WILL attract termites. note wires hanging down loose and original cedar piers in use

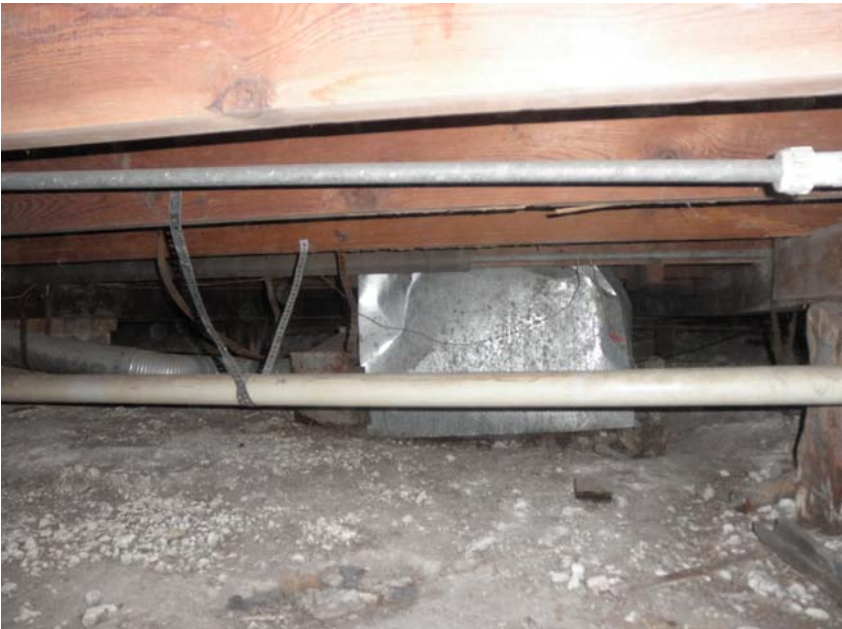
3 original furnace still under home

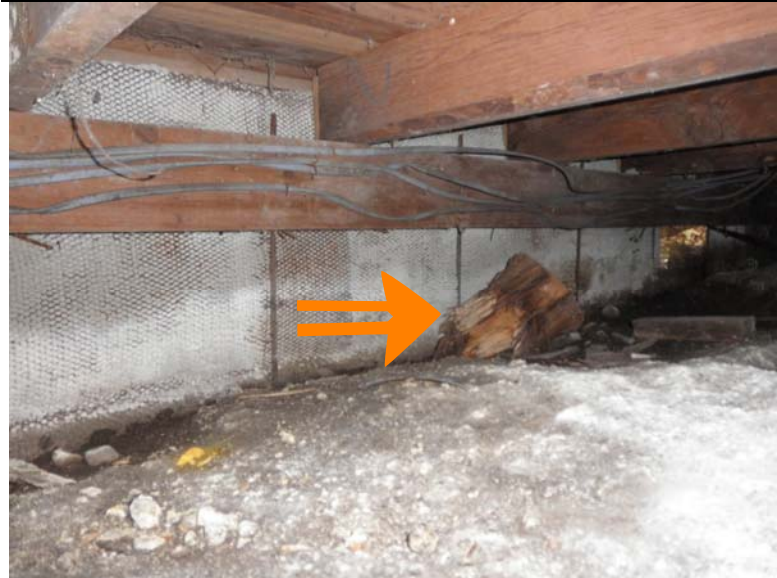
4 pier has fallen over leaving beam unsupported

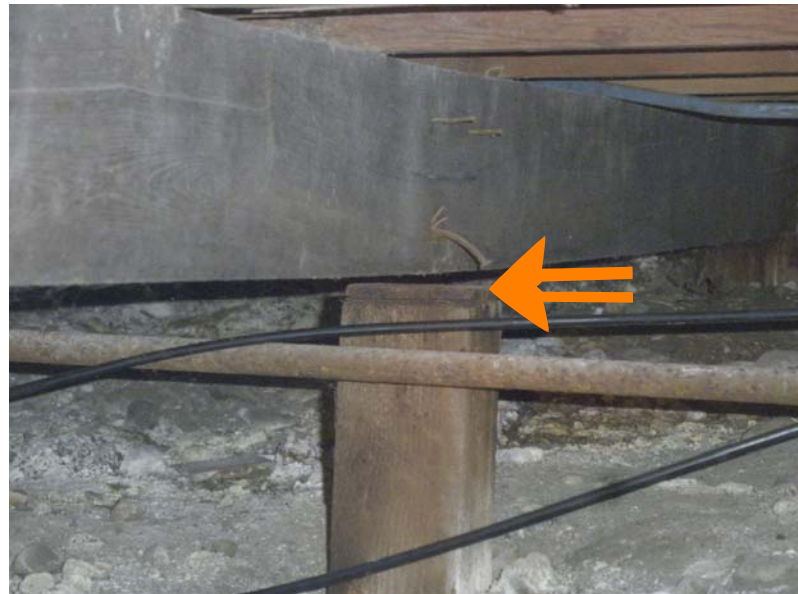
5 pier not supporting beam

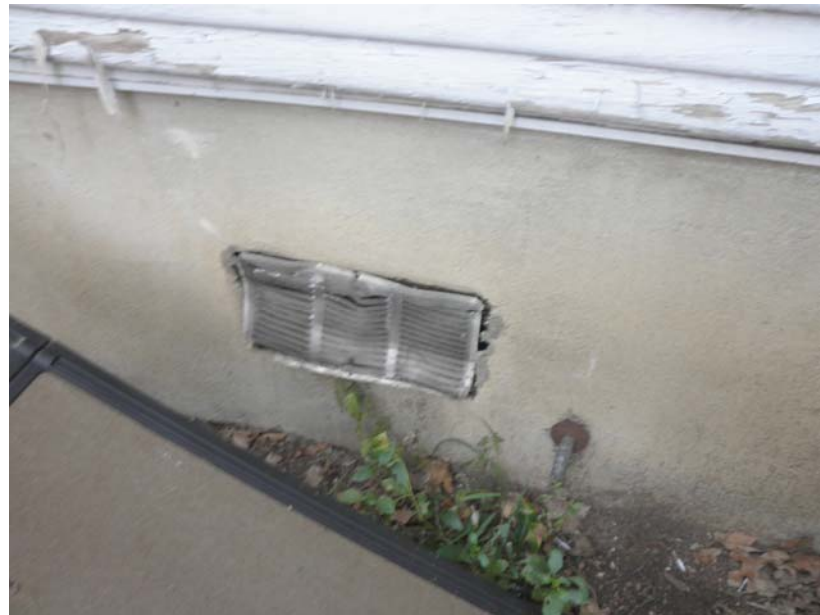
6 dmgd. air vent

Repair dmgd. air vents on both sides of foundation, seal up gap at foundation access door under deck to keep animals out, piers spaced too far apart.

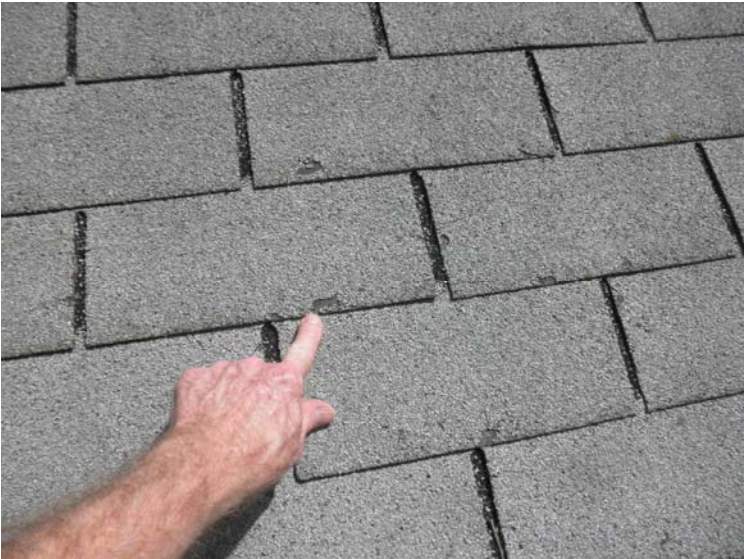
1st layer of shingles around edge of roof aren't glued down, clean out gutters (screens recommended), roof has hail damage (have seller make claim)

7 hail hits

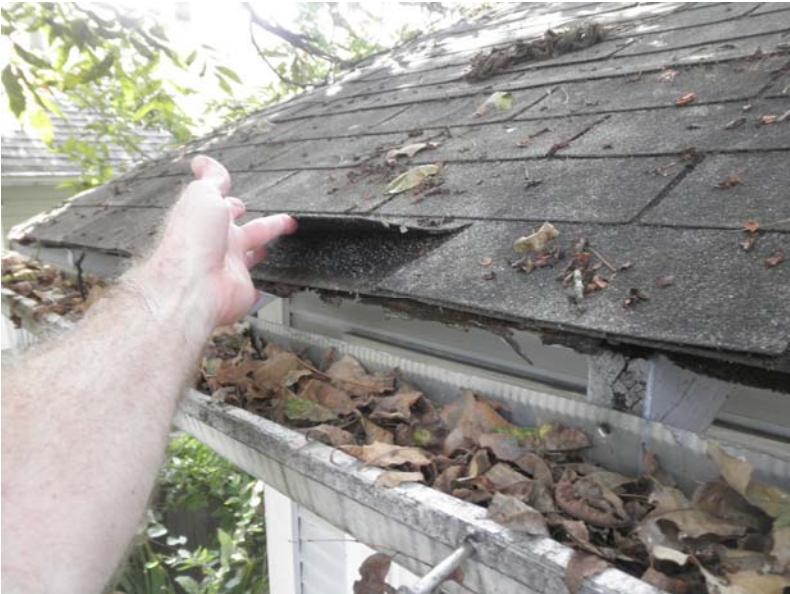
8 edge shingles not glued down, note full gutters

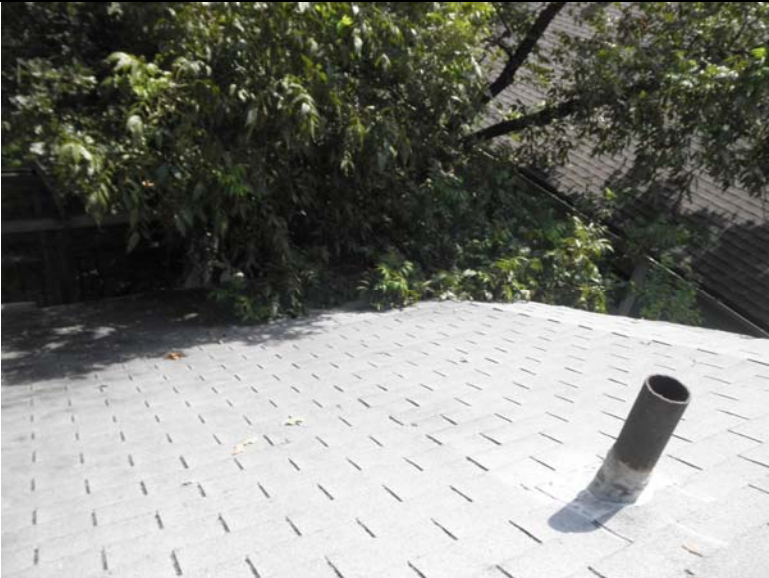
9 trees touch roof

Lower the flashing on the water heater flue; trim trees 5' away from roof to keep animals off, gutters loose and downspouts clogged

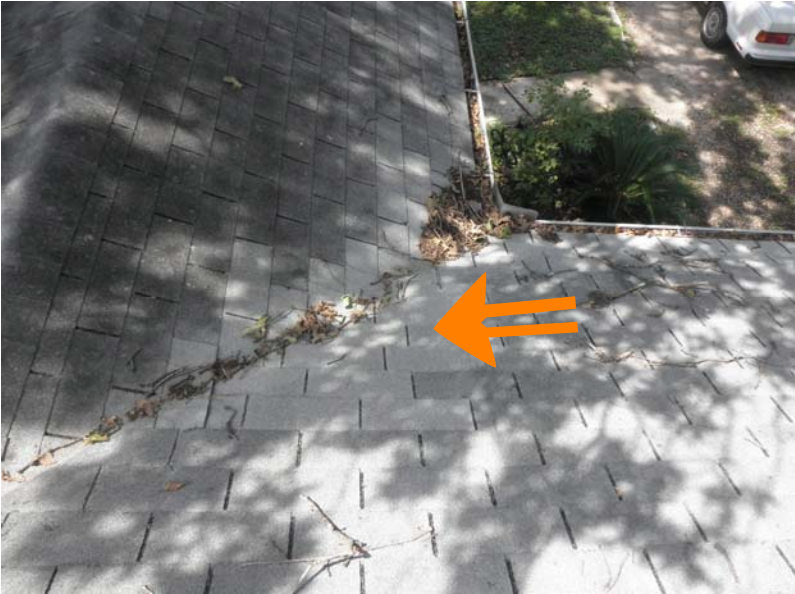
10 previous roof repair over foyer

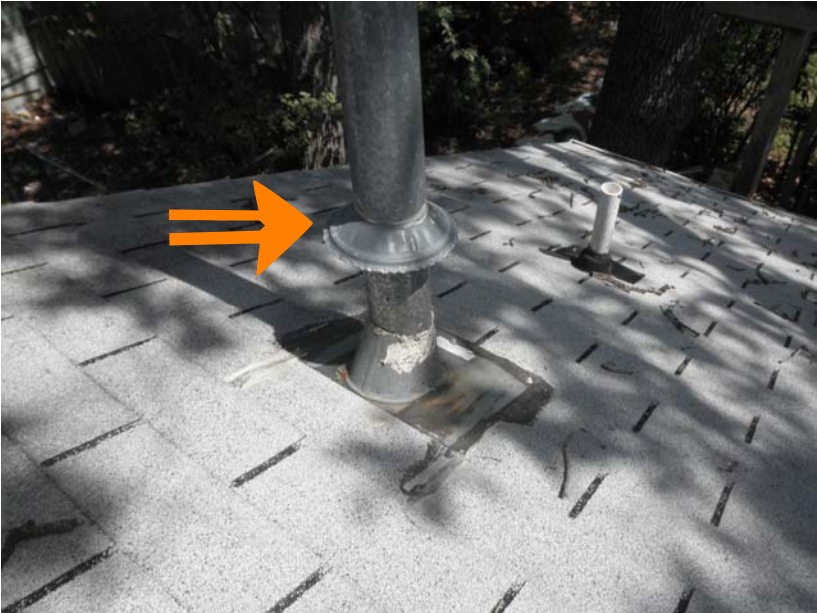
11 lower flashing 6"

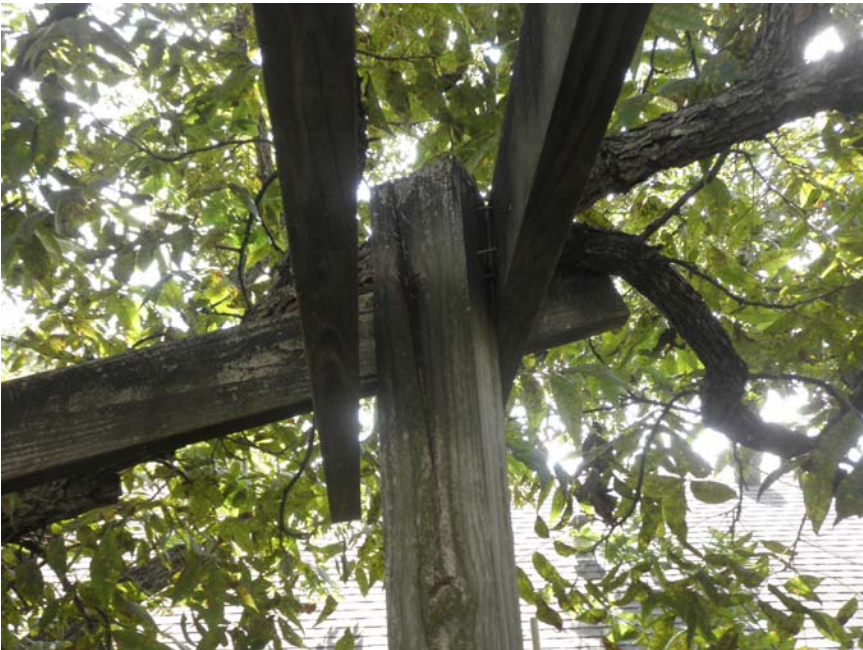
Wood framing over deck is wobbly and has nails coming loose (some of this lumber could come down at any time !). Some areas of the attic have missing or loose insulation. Posts holding up front porch roof have rot along the bottom and should be sitting on metal brackets, not the cement.
-newer homes have 12" of insulation-

12 arbor getting ready to come apart

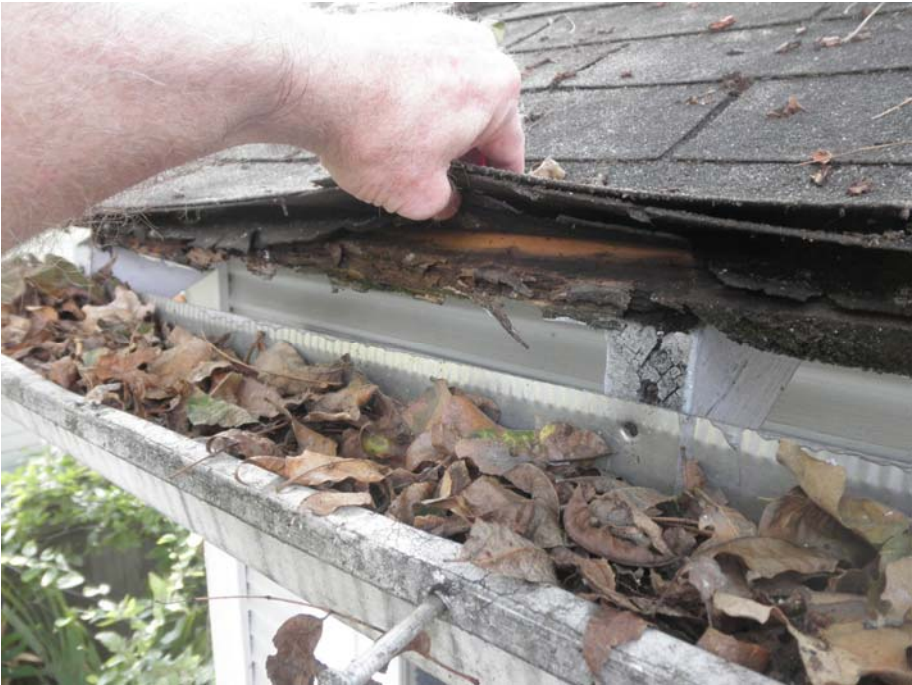
13 wood under shingles rotted, next photo too

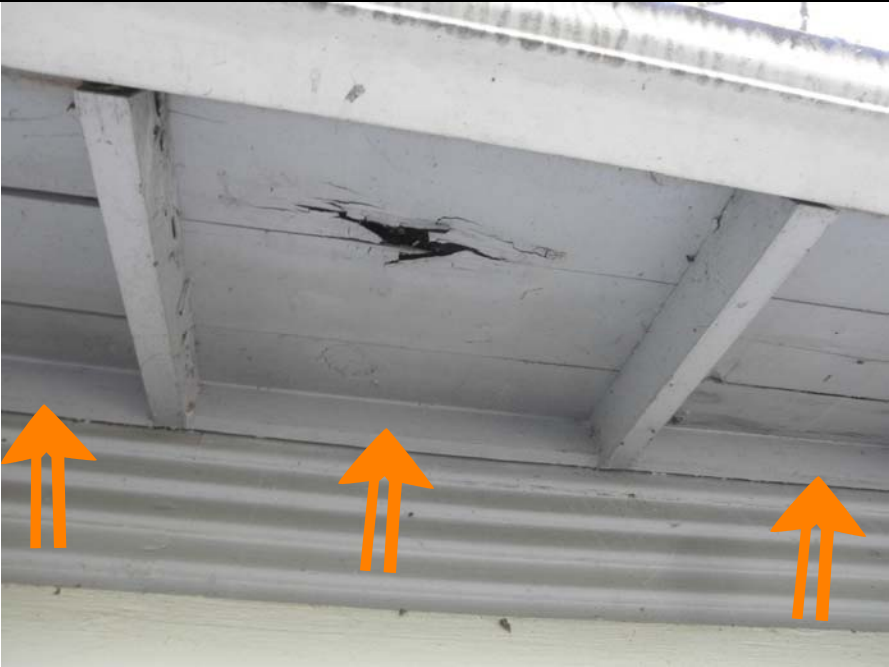
14 note missing air vents as well, arrows

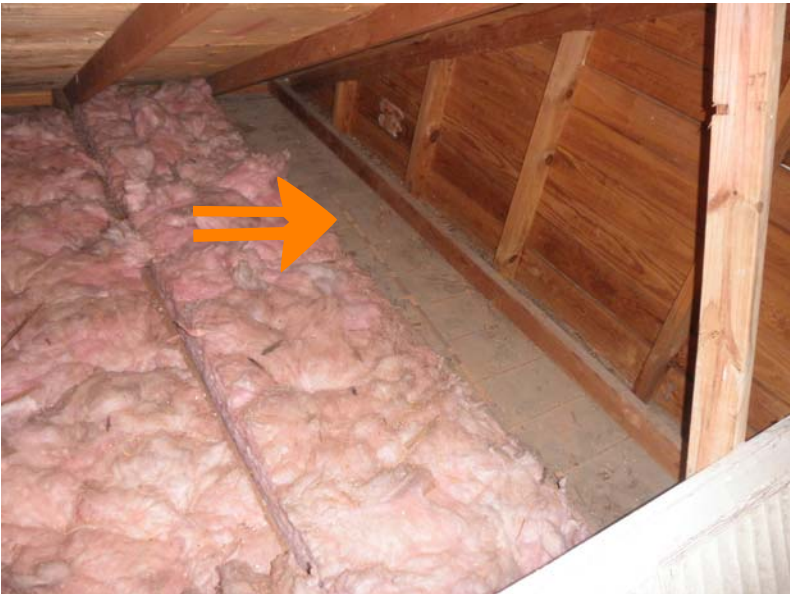
15 insulation missing over back BR

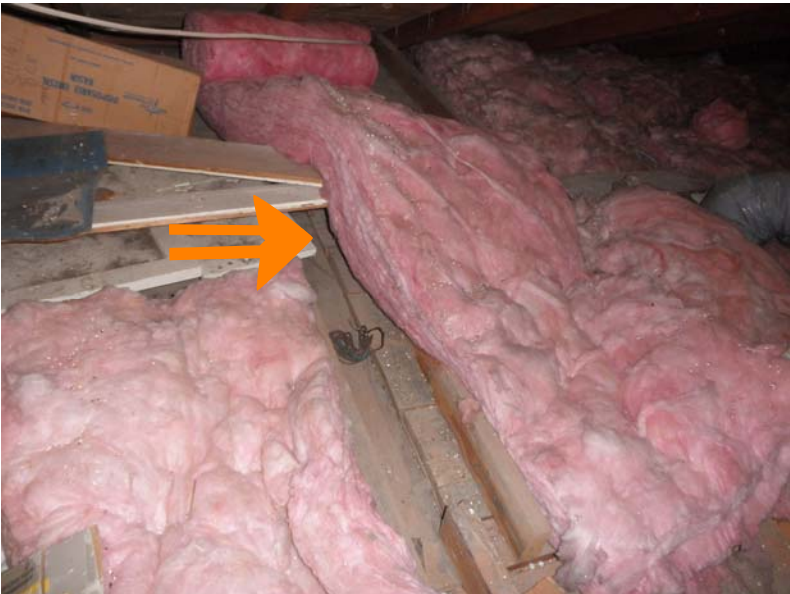
16 loose insulation, must lay FLAT on the ceiling to have any effect

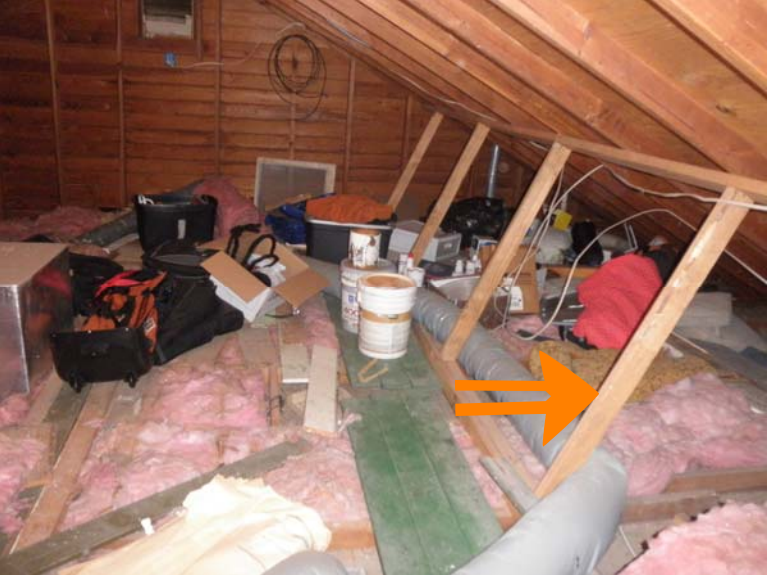
17 lots of stuff in attic, some may be from previous tenants
note: rafter supports don't comply with current stds. but ARE adequately supporting the roof

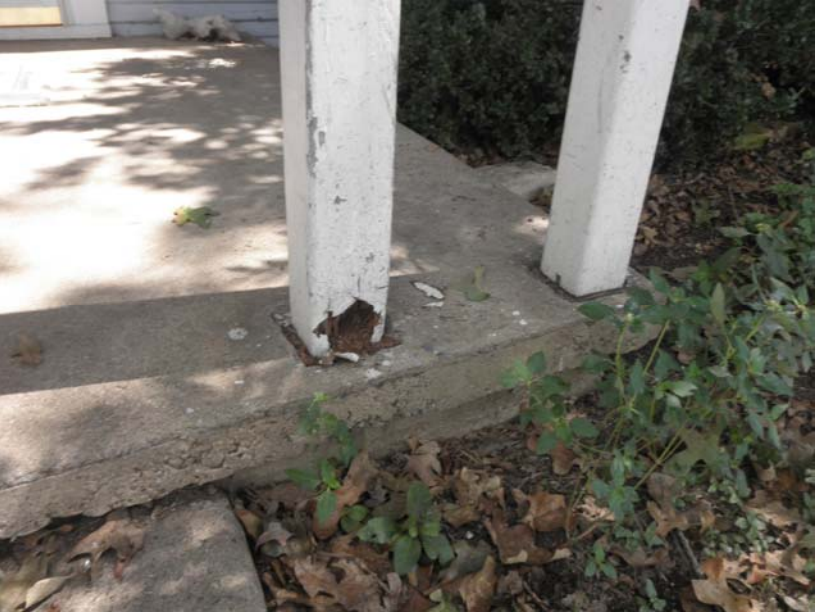
18 wood rot to front porch posts + brackets under them are missing

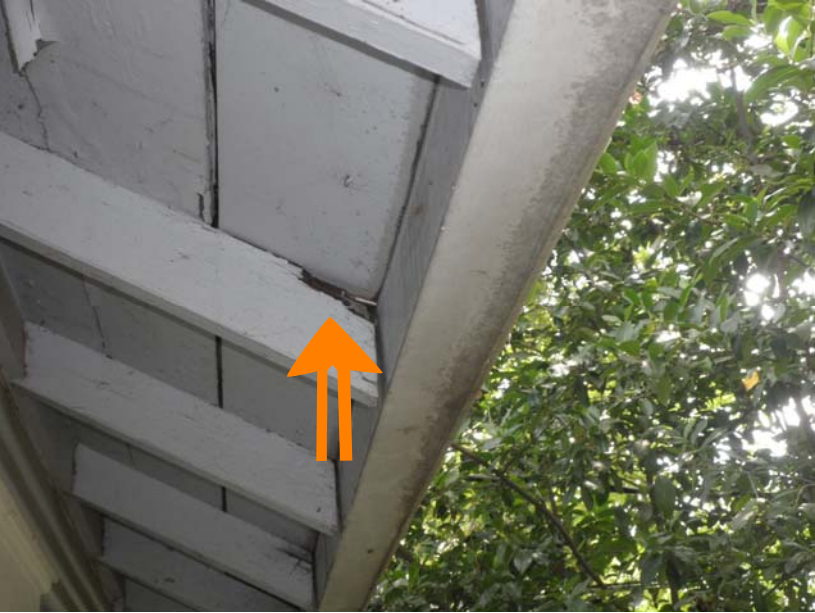
19 minor rot to front rafter "tails"

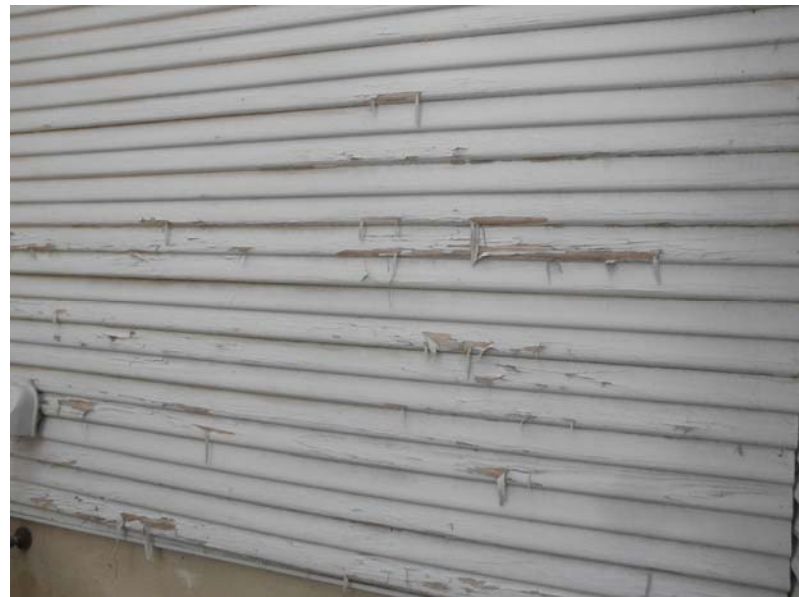
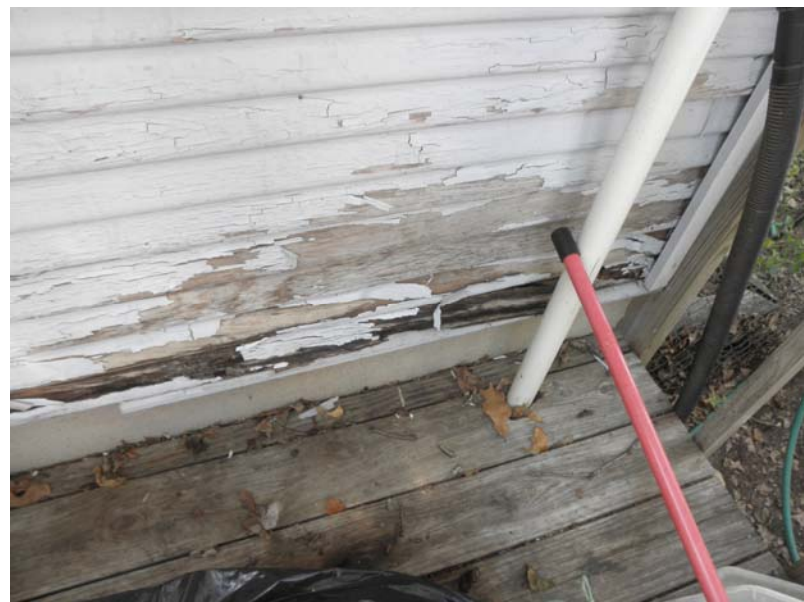
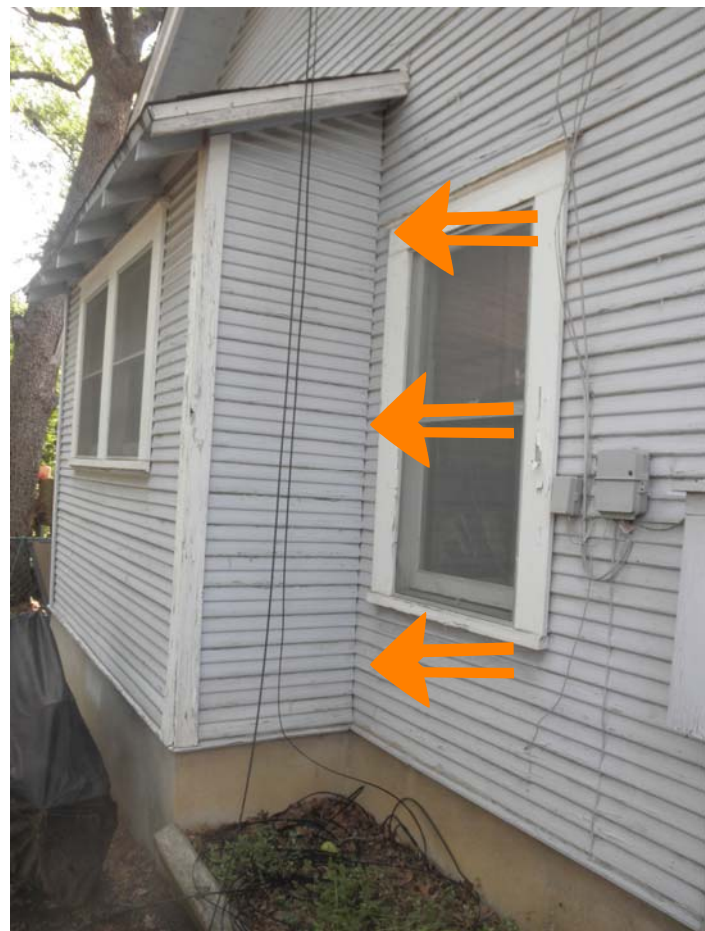
house needs paint inside and out, repair rotted siding on back of home,
caulk siding outside the kitchen (gap in corner)

20 caulk siding gap on left

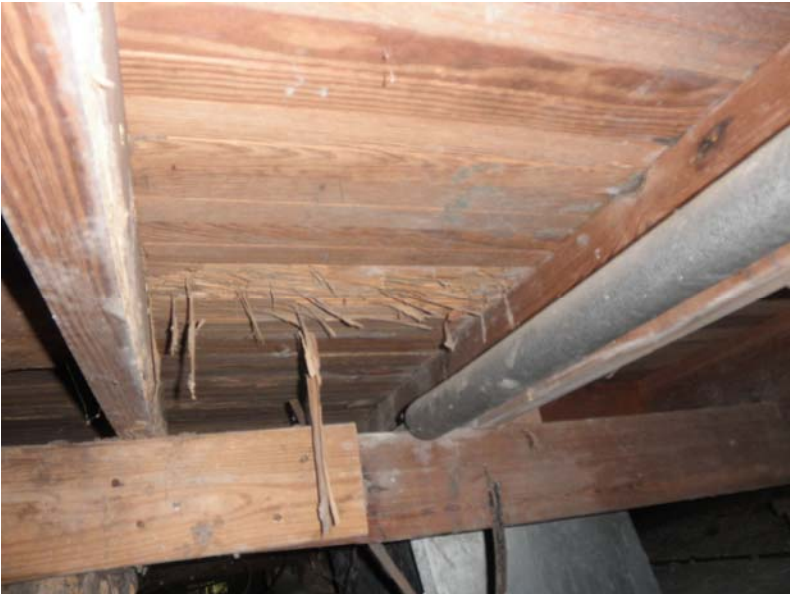
21 old termite dmg. to floor under DR

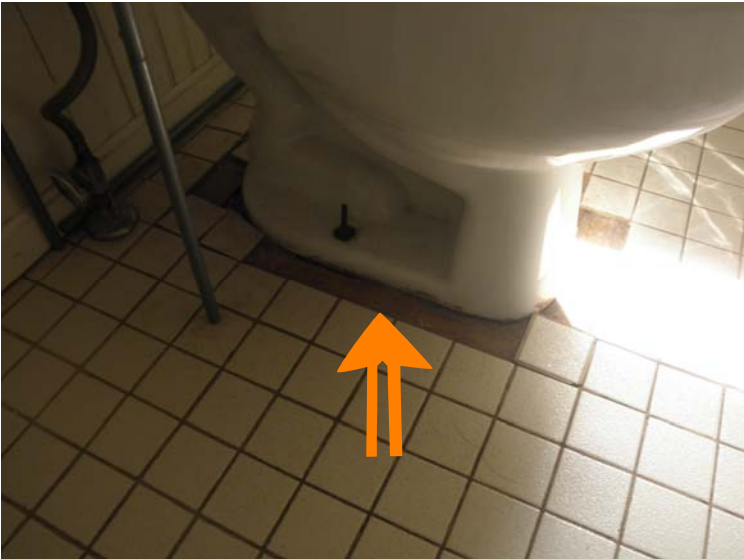
*tiles missing under toilet and wood rot present, floors slope due to foundation type
-newer homes have insulation on the underside of the floor-*

missing tiles

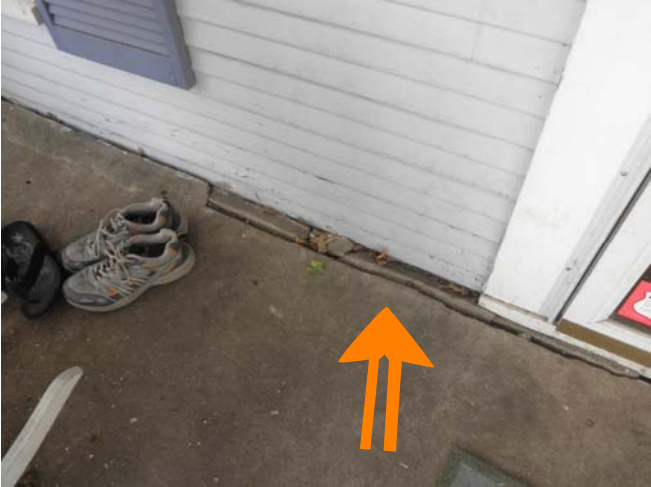
concrete cracked at front porch and metal flashing is needed where is attaches to front of home to keep water from seeping in under building. A few pickets missing at deck railing (also, space between railings wider than current stds. allow, infant fall hazard)

cracked + flashing missing

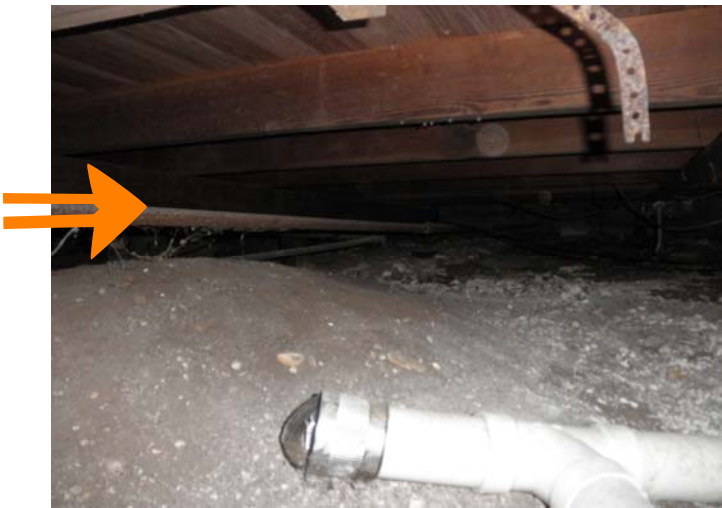
22 loose gas line under home, needs to be strapped up

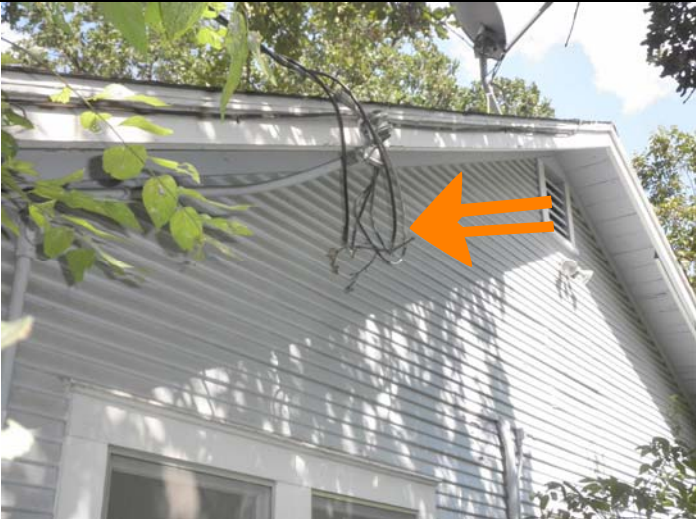
overhead powerline too low to the ground, should be up at least 10'; no main breaker, not req'd when this was built; panel has fewer circuits than in a modern home

23 low powerline

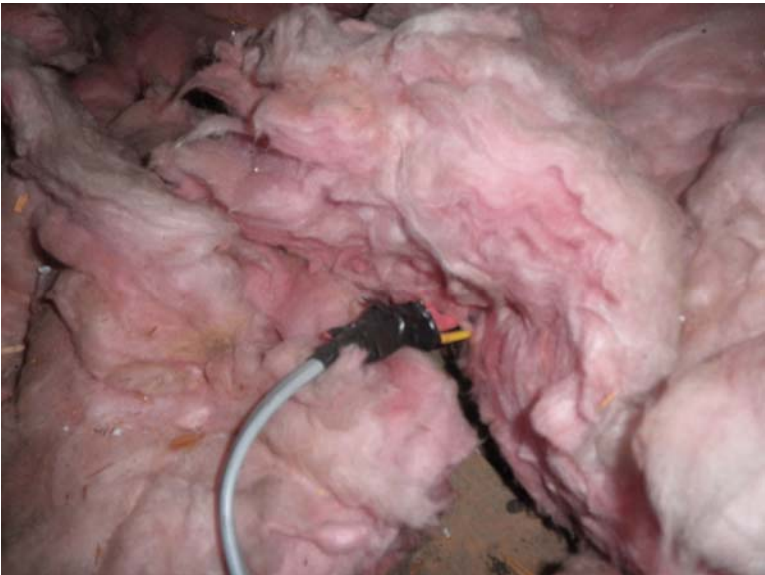
24 wire splice not in junction box over front BR

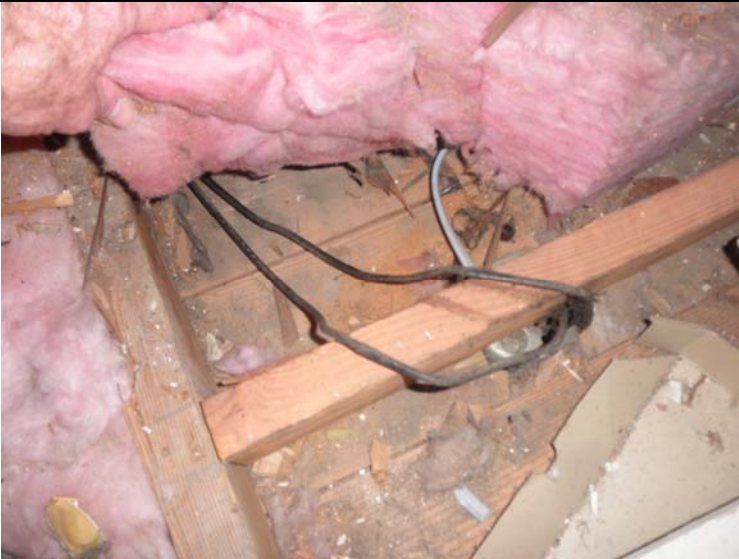
25 some original wiring in use

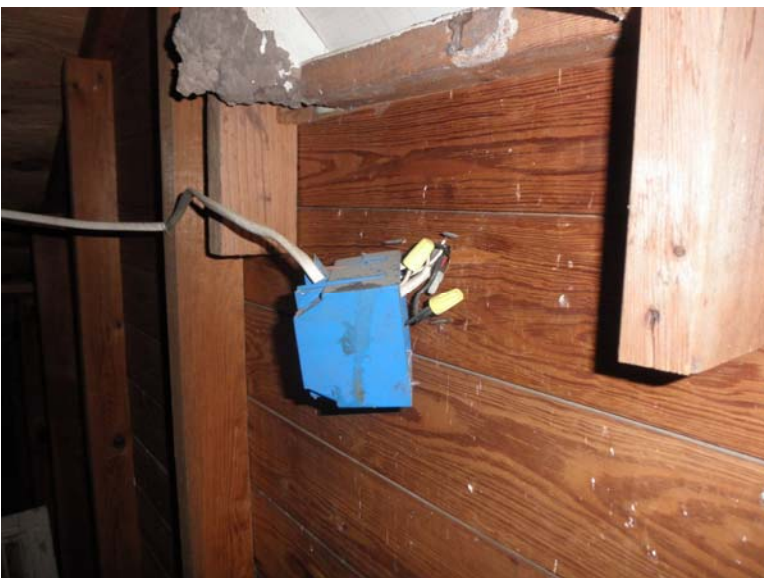
26 open wiring box at right side of attic

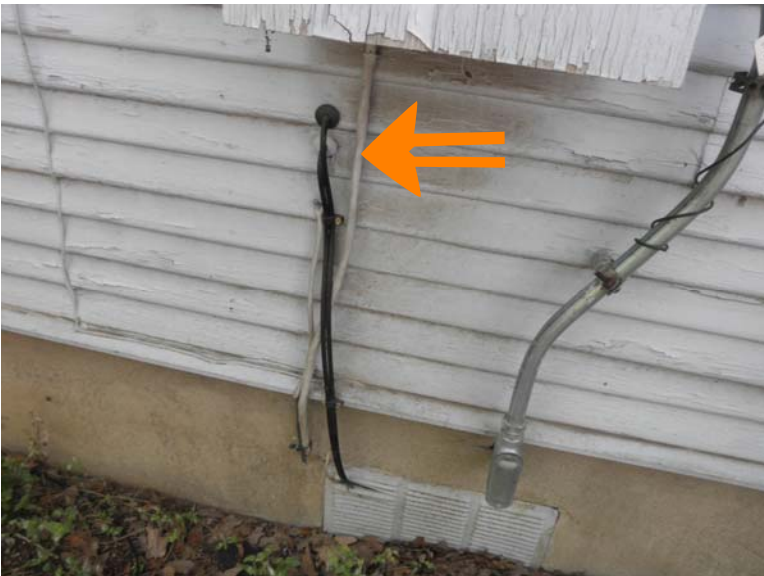
Wiring under left breaker panel needs to be in conduit for protection. Ungrounded outlets in DR, LR and BR's (either ground them or install gfi's). Loose outlet in back BR.
note: no 220v outlet at dryer, you can only use a GAS dryer (unless you have electrician run a new circuit into laundry)

27 wiring under breaker panel not in conduit

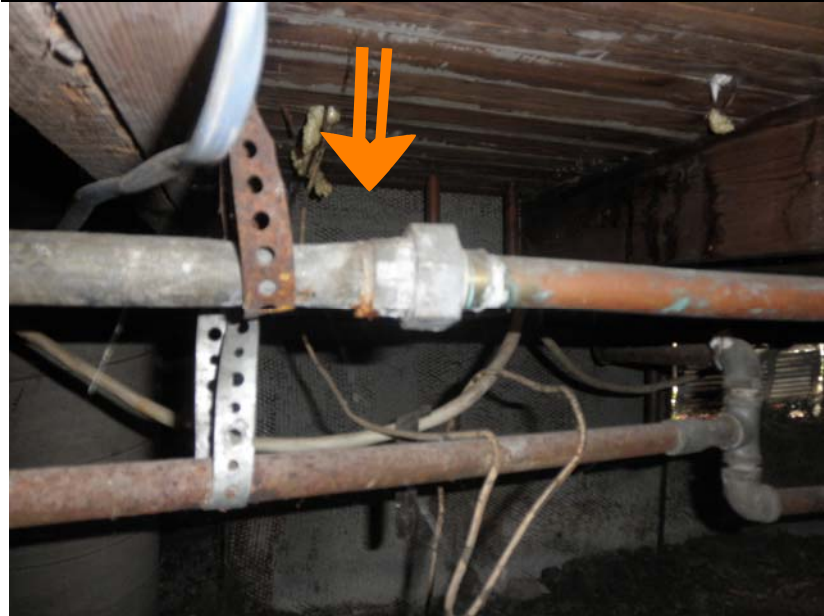
30 example of a dielectric union (needed wherever steel pipes connect with copper)

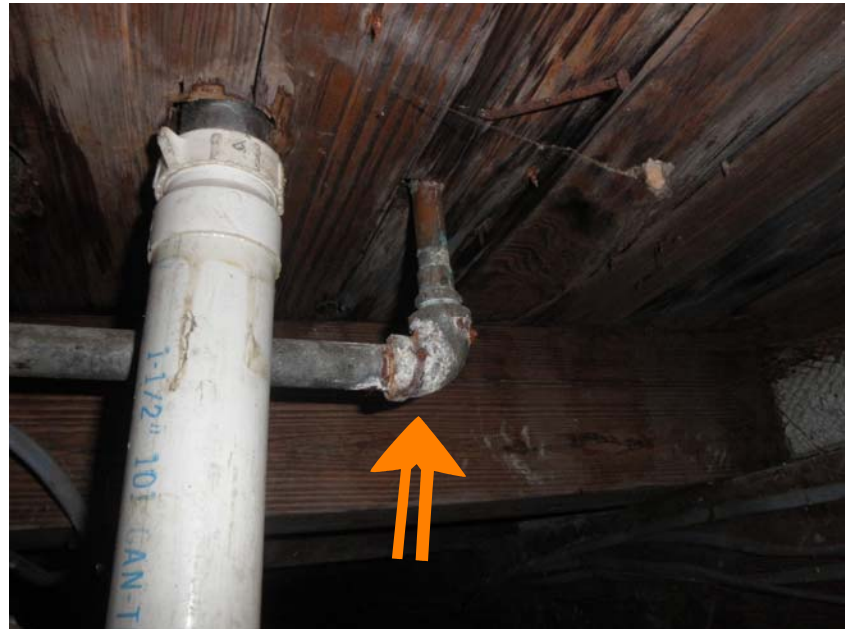
31 more corroded pipes, this is under bath

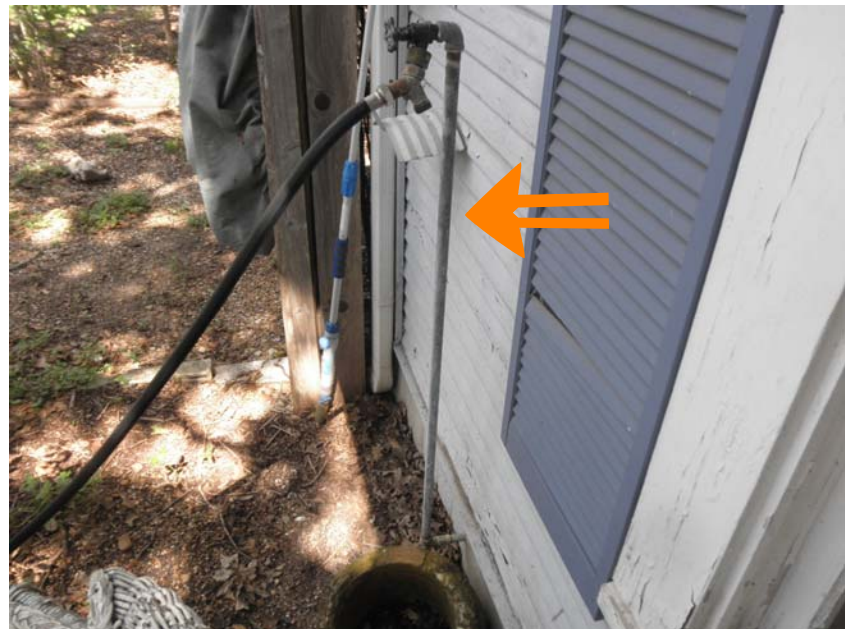
32 faucet loose, strap to siding

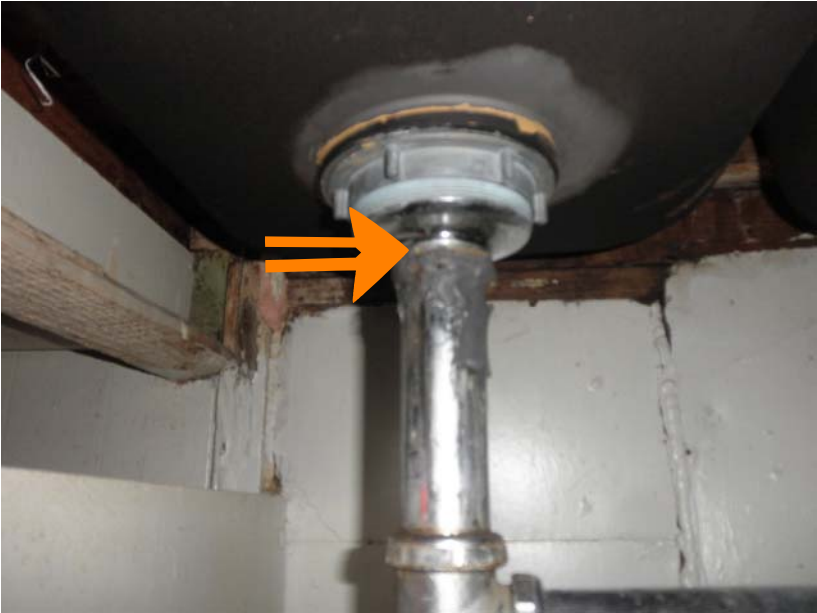
33 missing part from kit. drain pipe

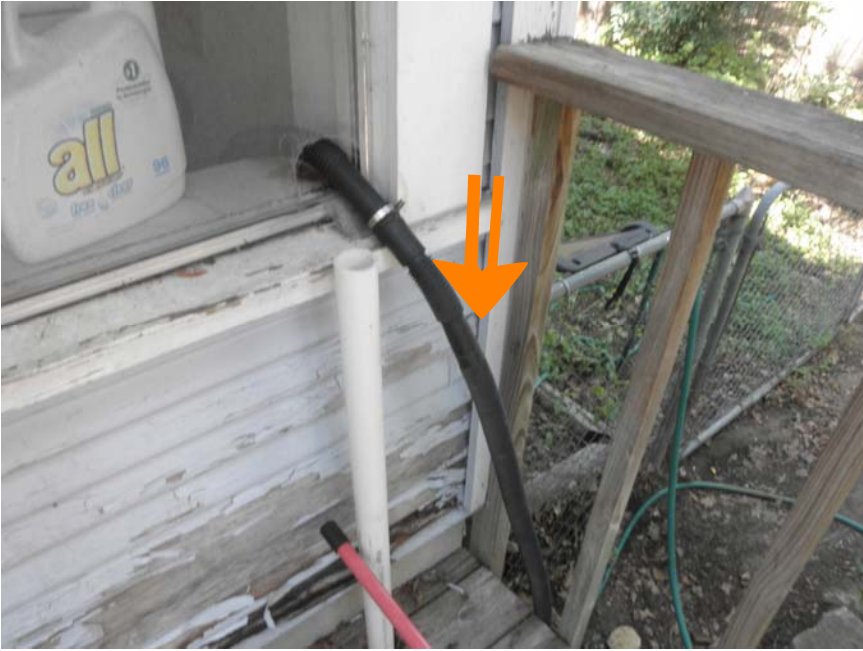
34 washer drains to yard
