Precision Inspection, PLLC

Property Inspection Report

123 Sample Address, Austin, TX 78712

Date of Inspection: 7/1/2019 Time: 1:00 PM

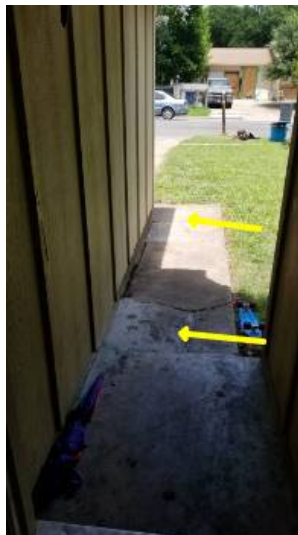
A.2. Previous foundation repairs observed on front sidewalk concrete.

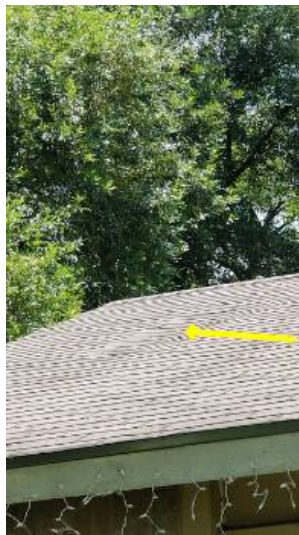
D.3. Roof decking is cupping in several places on the front side of the of the roof.

roof decking damage on the front left corner of the house

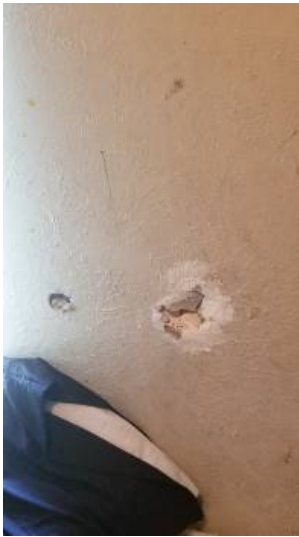
E.1. Left front bedroom- sheetrock is damaged on the front and right walls.

damaged sheetrock left front bedroom

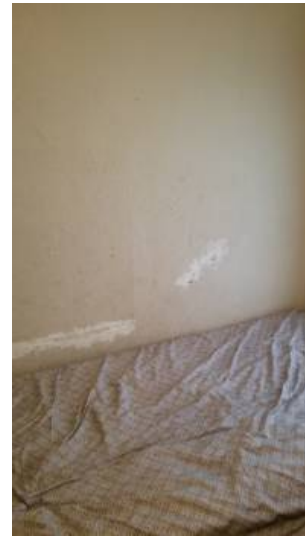
damaged sheetrock left front bedroom.

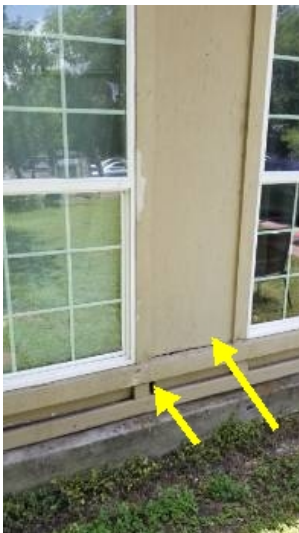
E.2. Exterior siding and trim is rotted in several places on all sides of the house.

siding and trim damaged front side.

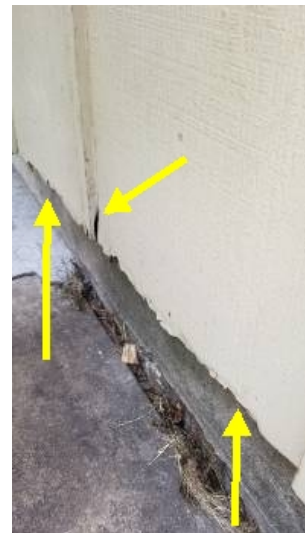
siding and trim damaged left side of converted garage.

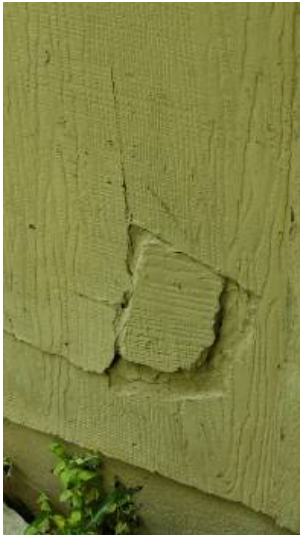
damaged siding on the left side of the house

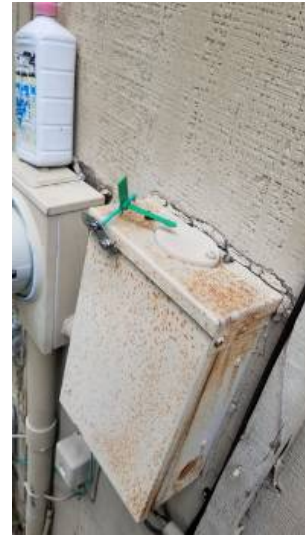
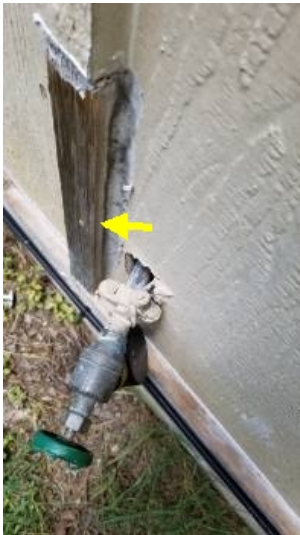
damage wall trim

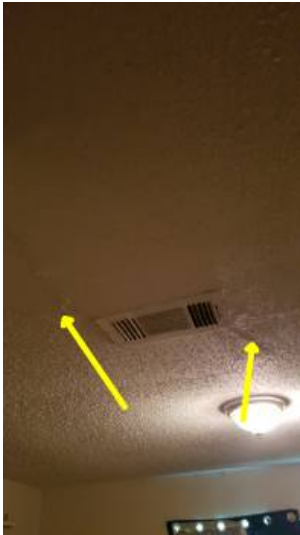
F.6. Right back bedroom- ceiling sheetrock is cracked and is sagging by the AC register.

ceiling sheetrock cracked and sagging

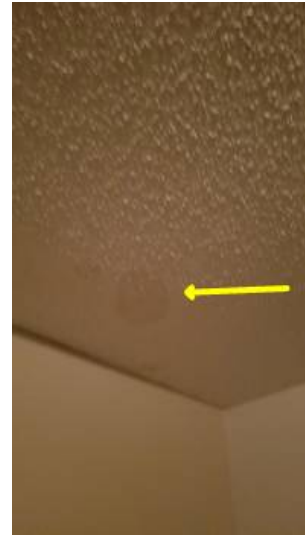
F.7. Left back bedroom- water stains observed on the ceiling sheetrock.

water stain on ceiling sheetrock.

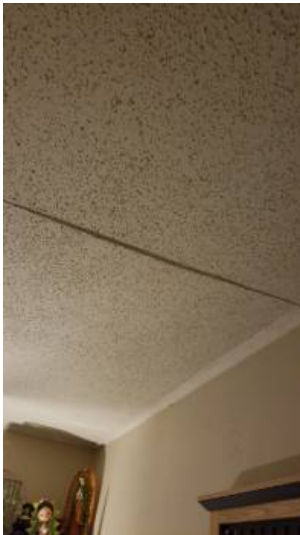
F.8. Converted garage ceiling sheetrock is sagging.

converted garage ceiling sheetrock sagging.

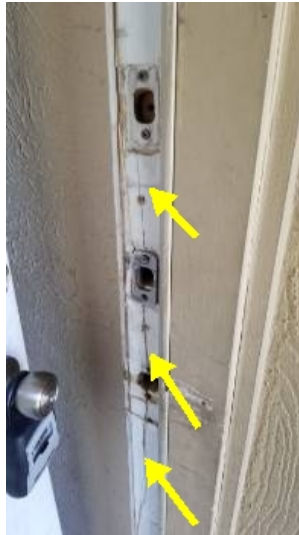
G.5. Front door jamb is damaged at the striker plate area.

Front door jamb is damaged at the striker plate area.

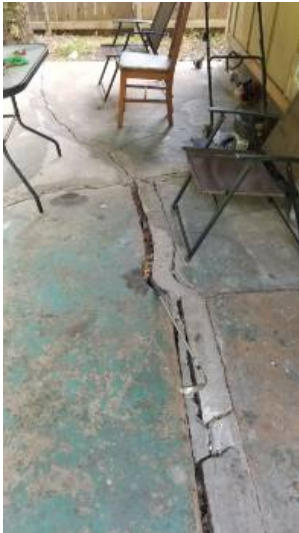
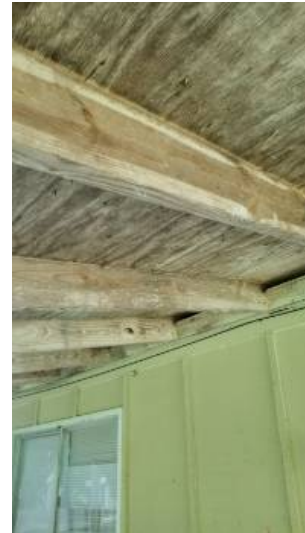
[K.1. Back patio concrete slab is cracked and lifted in several areas.](#)

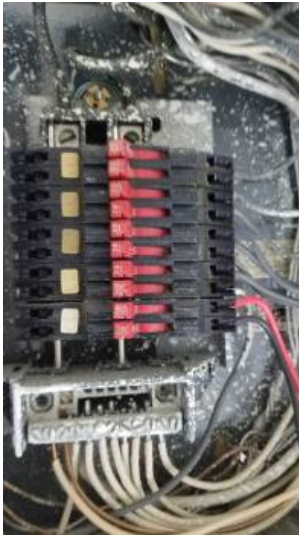
A.2. Both electrical panel boxes are zinco brand. These electrical panel boxes are considered a safety hazard. Recommend replacing electrical panel boxes.

Both electrical panel boxes are zinco brand. These electrical panel boxes are considered a safety hazard. Recommend replacing electrical panel boxes.

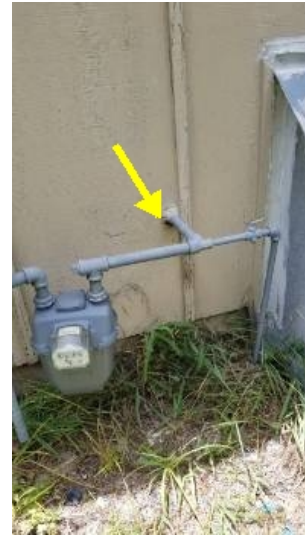
A.1. Gas lines are not bonded to electrical panel. Wasn't required when house was built.

Gas lines are not bonded to electrical panel. Wasn't required when house was built.

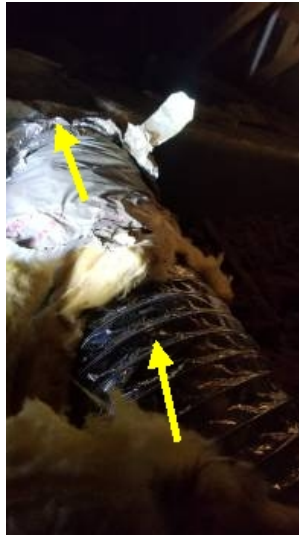
C.1. AC ductwork for converted garage area- flex duct insulation is damaged on the flex duct work. Poor connection from the flex ductwork to the flex board ductwork.

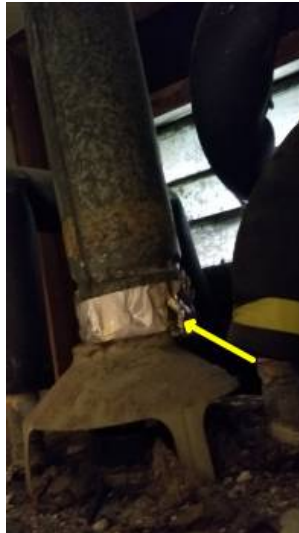
[C.2. Water heater vent pipe is not connected to the water heater vent hood.](#)

Water heater vent pipe is not connected to the water heater vent hood.

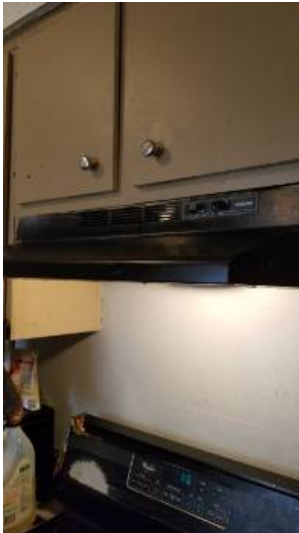
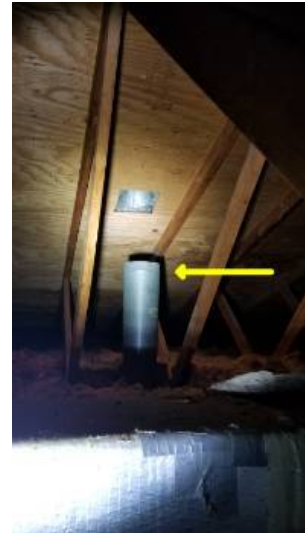
C.2. Range hood vent pipe terminates in the Attic. Fire safety hazard.

range hood vent pipe terminates in attic.
